American Testing Services, Ltd.
3060 East River Road
Dayton, OH 45439

On-Site Inspection Report

100% of welds on floor of chromic acid waste tank

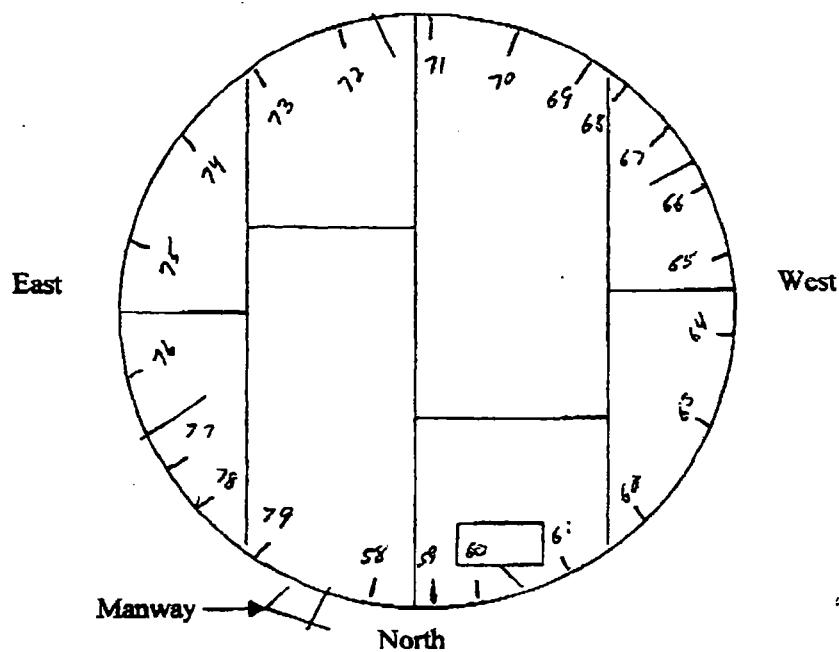
READINGS AND LOCATIONS SIDE WALL
South

Well thickness
Readings.

Aug. 0-25 in

58.	.253	69.	.255
59.	.254	70.	.267
60.	.252	71.	.264
61.	.248	72.	.266
62.	.246	73.	.268
63.	.249	74.	.264
64.	.252	75.	.262
65.	.255	76.	.259
66.	.260	77.	.248
67.	.260	78.	.255
68.	.256	79.	.253

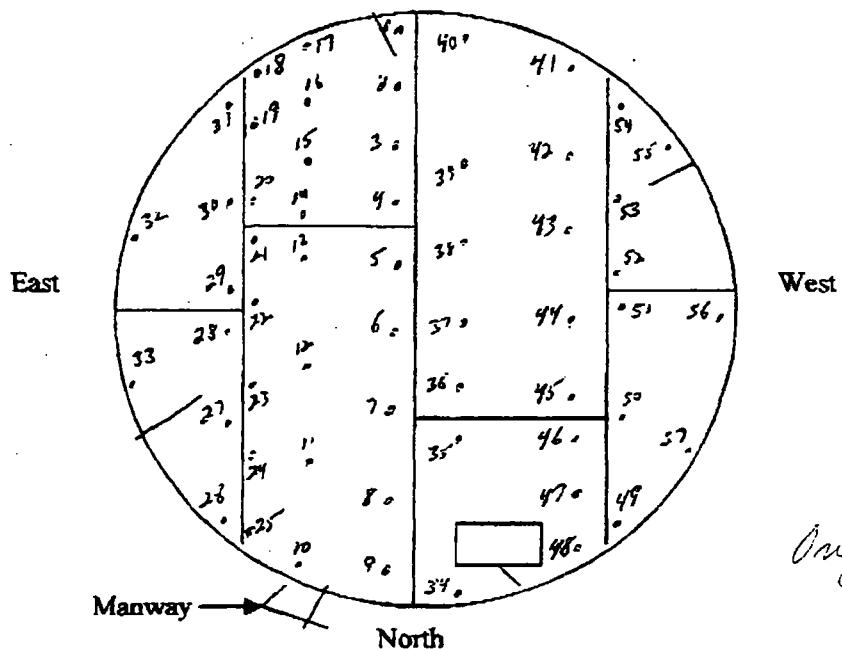
**READINGS AND LOCATIONS OF FLOOR
South**

Floor reading.

Aug. - 0.25 in

1.	.266	16.	.272	31.	.264	46.	.268
2.	.287	17.	.280	32.	.263	47.	.260
3.	.283	18.	.270	33.	.262	48.	.270
4.	.245	19.	.221	34.	.244	49.	.276
5.	.254	20.	.243	35.	.268	50.	.257
6.	.246	21.	.251	36.	.250	51.	.256
7.	.246	22.	.246	37.	.258	52.	.256
8.	.262	23.	.239	38.	.246	53.	.259
9.	.257	24.	.263	39.	.268	54.	.258
10.	.268	25.	.230	40.	.253	55.	.246
11.	.249	26.	.264	41.	.248	56.	.268
12.	.239	27.	.265	42.	.266	57.	.263
13.	.254	28.	.247	43.	.257		
14.	.239	29.	.255	44.	.253		
15.	.265	30.	.255	45.	.257
